CORROSION UNDER STRESS:

The Development & Application of Corrosion Control Solutions for Prestressed Concrete Structures

Jack McLean – Engineering Manager: Freyssinet Australia

BLB 1

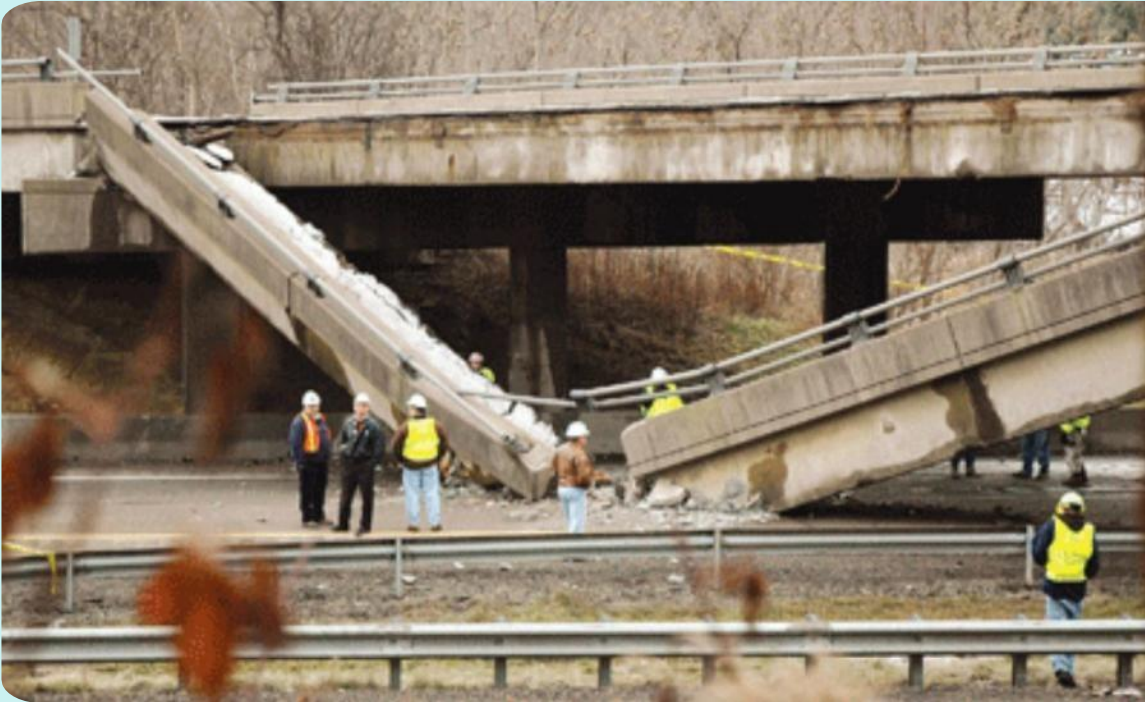
- Whilst it is more resistant to corrosion, when it does occur, the implications are substantial.
- Corrosion of Prestressed Tendons can result in catastrophic failure of the element:
 - **Brittle Fracture** – Exceeding the load capacity
 - **Stress Corrosion Cracking** – Caused by anodic stress corrosion and hydrogen induced stress corrosion cracking.
 - **Fatigue and Corrosion Influences** – corrosion fatigue cracking & fretting corrosion
- In all instances, failure is caused by substantial loss of ductility and therefore, early identification is **imperative**.

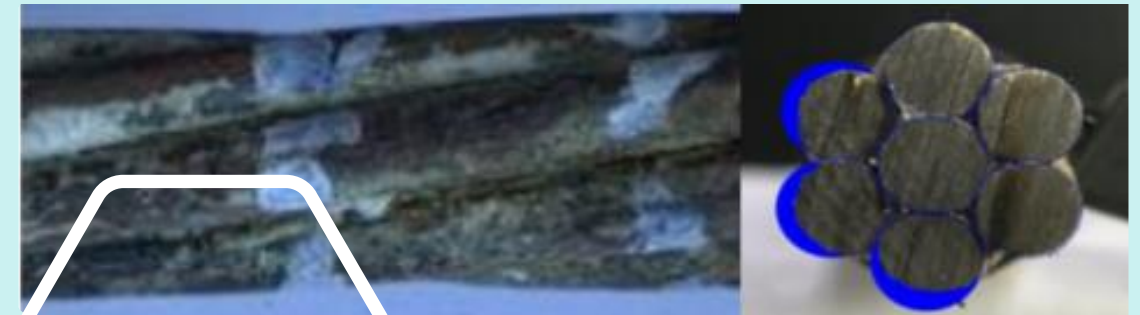
- Traditional RC corrosion is visually identifiable through cracking/spalling/delamination – **Easy to Identify**
- Prestressed elements corrosion is often more **difficult to identify**:
 - Corrosion Product Buildup within the voids between the strands, resulting in less volumetric expansion.
 - Hogging bending effects from prestressed steel – compressive forces at the bottom of the element, reducing the visibility of cracking

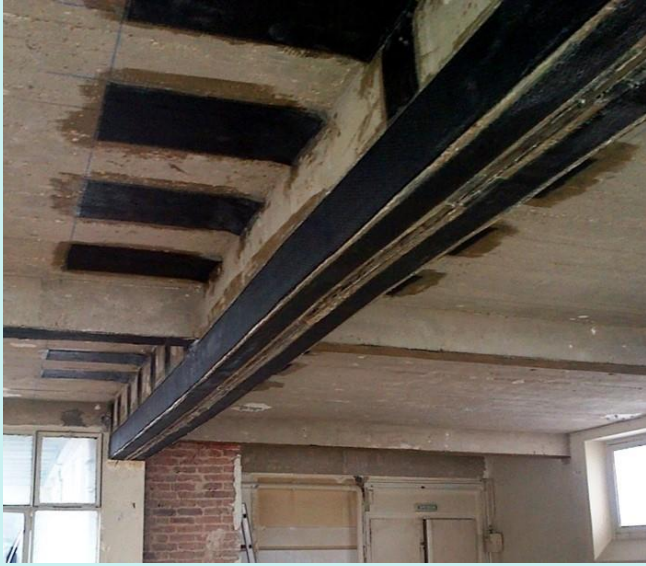
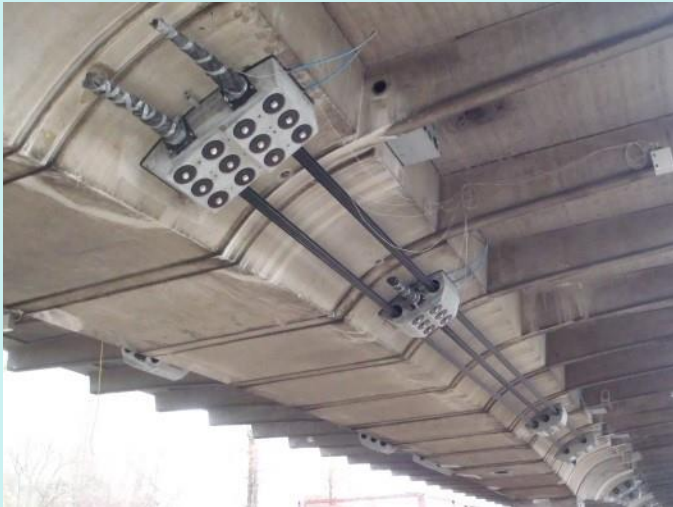
- Generally, traditional remediation techniques do not apply to prestressed concrete
 - Risk of Destressing or Damaging Very brittle strands
 - Augmentation of Strand is not possible
 - Supplementation of Structural Strength is required through external methods
-
- Carbon Fibre - Passive
 - External PT – Active
-
- External Repair Methods have their own limitations and challenges and often will not be able to 100% “augment” existing condition.

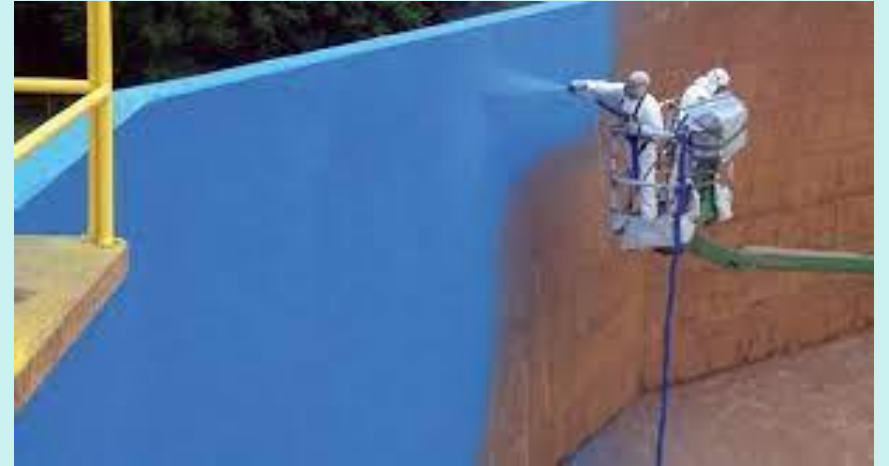
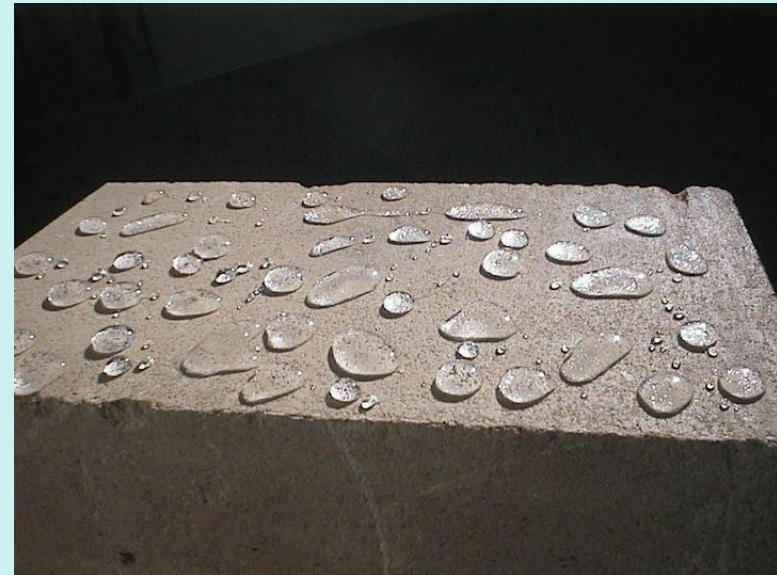
- “Mechanical Protection” systems refer to Physical Barriers that prevent or delay the ingress of Cl^- , O_2 , H_2O .
 - Penetrative Sealers – Silane/Siloxane
 - Barrier Coatings – Epoxies, PU
-
- Effective at the early stages of contamination but are less effective once critical thresholds have been achieved.
 - 10-15 year service life

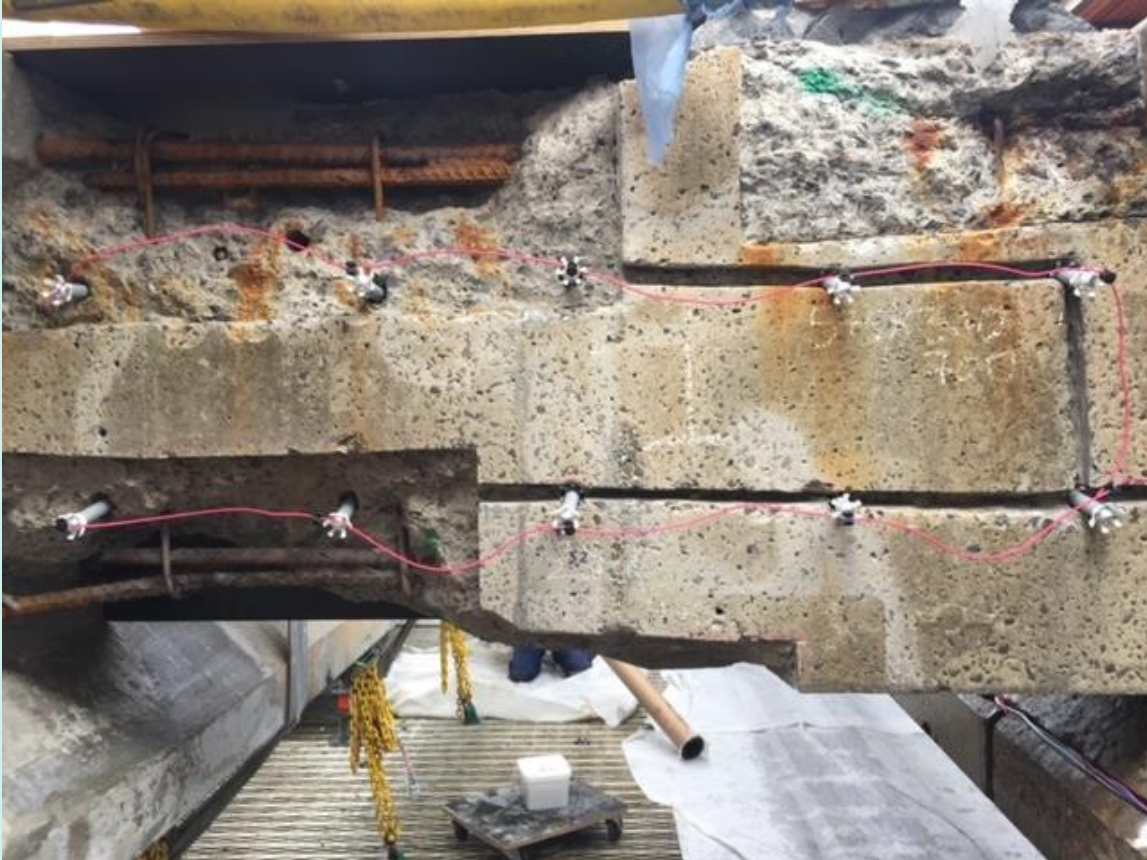
- Application of Cathodic Protection will serve two key purposes:
 1. Draw the Cl^- away from the steel \therefore **maintain alkalinity**
 2. Lower the electro potential of the steel to within the **immunity zone**
- Most Effective Strategy once Cl^- is at steel
- Complex/Expensive/Risky (Hydrogen Embrittlement)

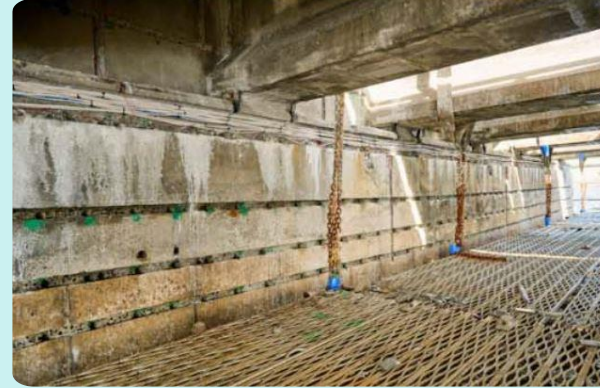
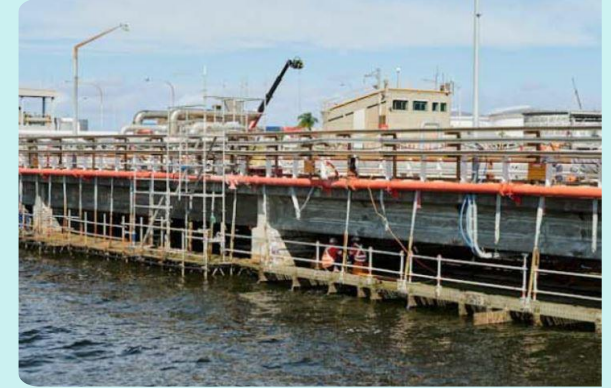
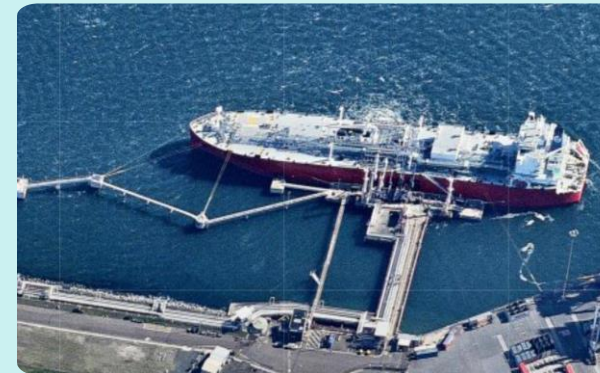
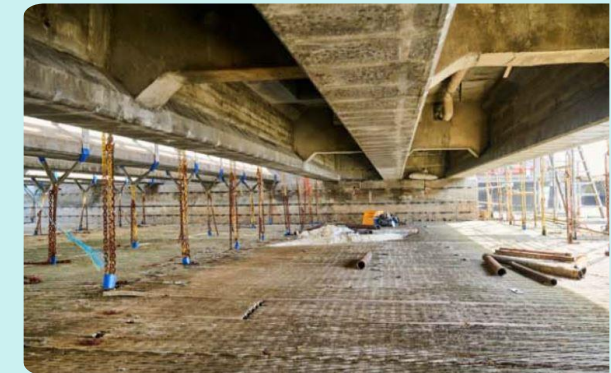
- Bulk Liquids Berth – Constructed in the 1970's
- Supply of Essential liquid products handling and distribution for NSW (Gas, Fuel, Bitumen etc)
- Traditional RC Wharf Structure with various pre-cast, prestressed concrete bridge elements – walkways, pipe bridges, catwalks etc.
- Aggressive Environment over 40 years since time of construction
- Considered a “Hazardous Area” due to volatility of the products being stored/handled on site.

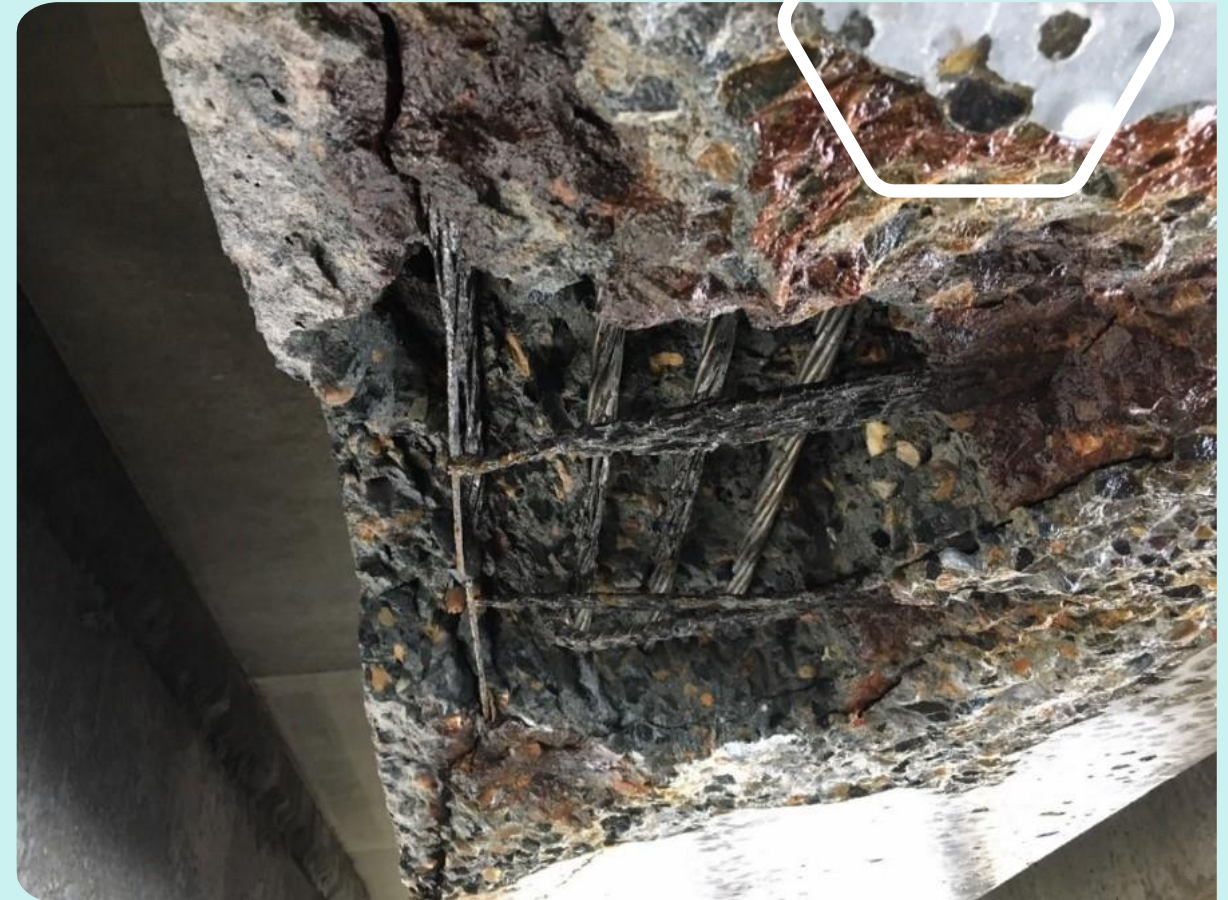
- The asset owner uses an asset management framework that includes a Marine Structures Inspection Program.
- Two Yearly Structural Condition Assessments for different elements, including:
 - Visual Inspection & Crack Mapping
 - Ferric Covermeter & GPR Scanning
 - Potential Mapping
 - Surface-Mounted Resistivity Analysis
 - Chloride Profiling & Diffusion Modelling
 - Carbonation Testing, and
 - Alkali Silica Reaction (ASR) Testing
- Ongoing/Worsening Corrosion Activity was identified to the majority of the precast, prestressed elements.

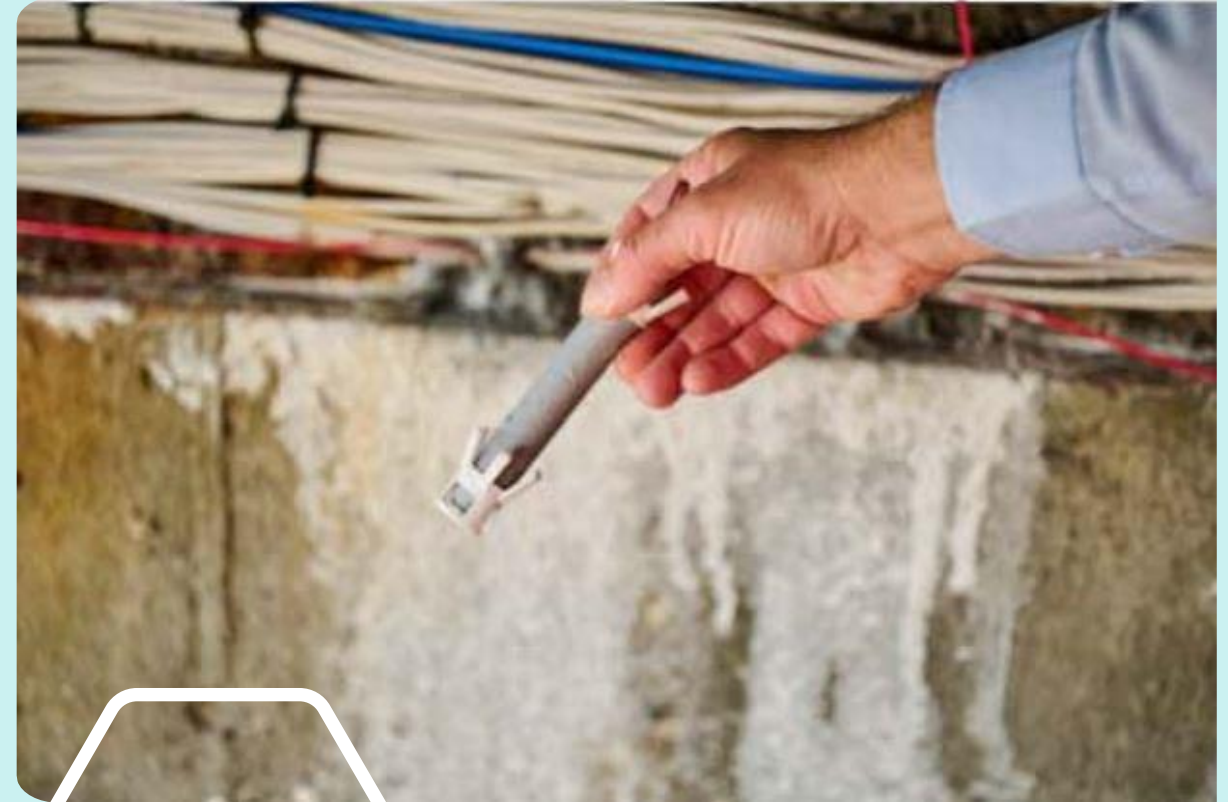
- Further Optioneering was undertaken, and a Hybrid Corrosion Protection Solution was adopted:
- Stage 1 – Energisation (Extract Cl⁻ away & Repassivate Steel)
- Stage 2 – Galvanic Stage (Maintain low Corrosion Rates through Galvanic *Zinc* Anode Arrangement)
- Reduced Risk to the structure – Minimal Chance of Hydrogen Embrittlement
- Simplified Maintenance & Monitoring Requirements
- Design included provision of 35,000 + Hybrid Anodes, 188 Zones - across the total structure

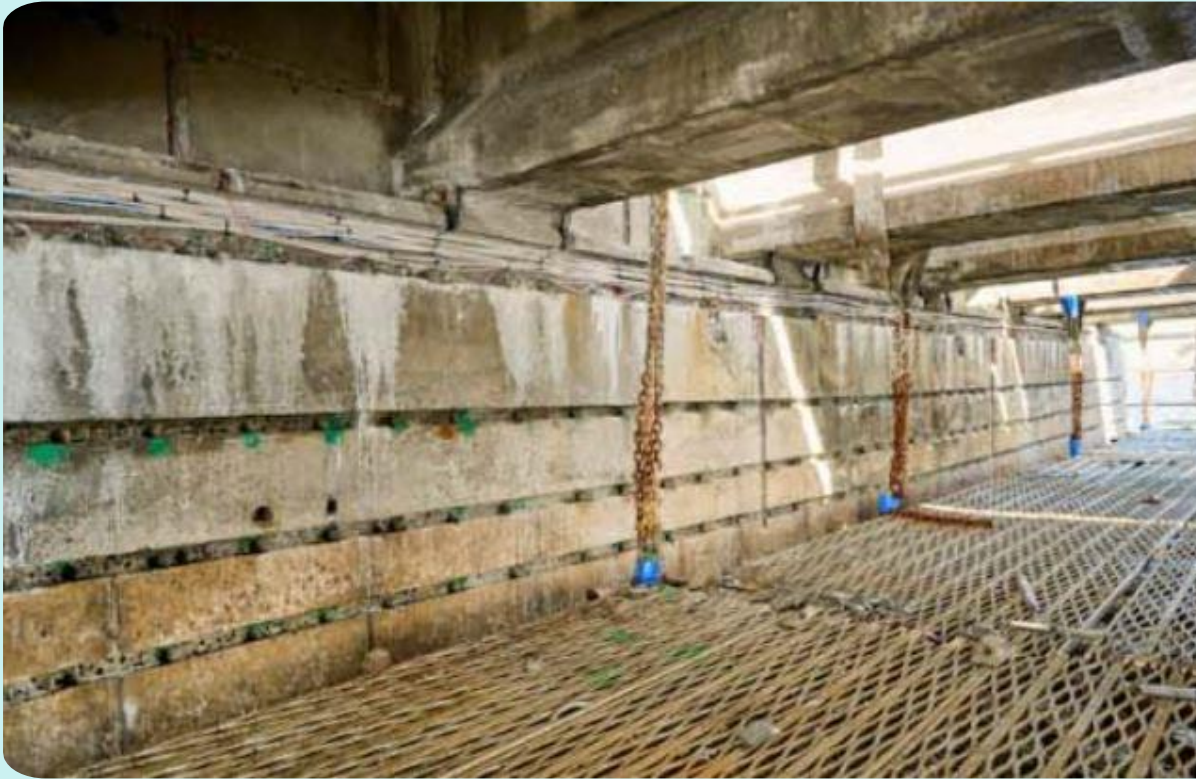
- Hybrid Corrosion Protection – Relatively New (~12 Years at the time this project was underway)
- Risk of further chloride ingress & redistribution of Cl⁻ : depassivation of steel over design life.
- Design Calculations were carried out to verify sufficient capacity for **additional impressed current treatments** over the design life:
- Impressed Current Energisations at:
 - Year 0
 - Year 15
 - Year 30
- System Zoned & Wired in such a way as to allow for ad-hoc monitoring/energisation over this period

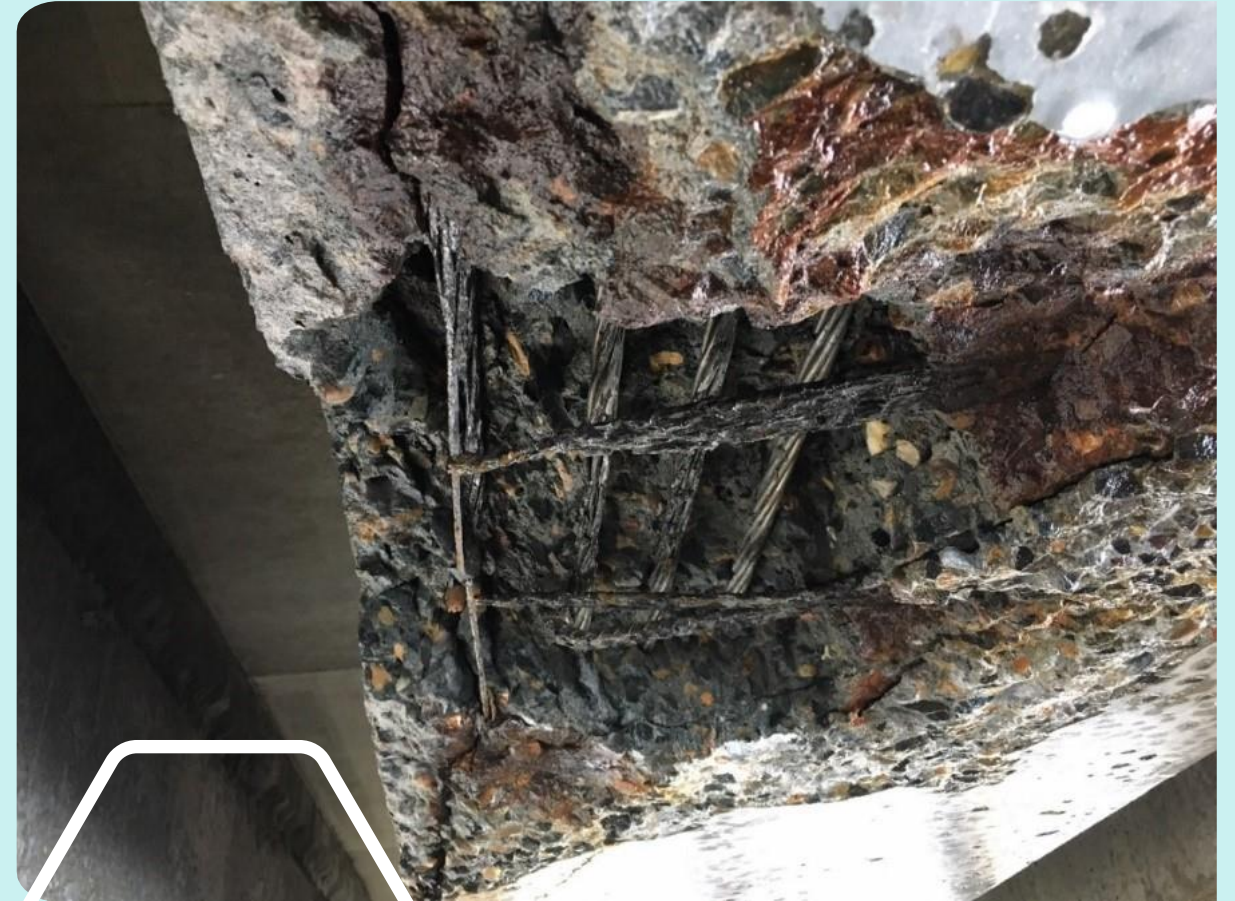
- The **Energisation Phase** of Hybrid Corrosion Protection is when the structure is at the **Highest Risk of Embrittlement**.
- For RC Structures – Energisation is typically applied at a constant voltage $\sim 8V$ dc (7-28 days)
- For Prestressed Concrete – This must be much lower.

- Limiting the size of zoning - more control/resolution
- Increasing qty of permanent reference electrodes
- Adopting a conservative potential limit $-800mV_{ssc}$
- Specifying an alarmed, monitoring system

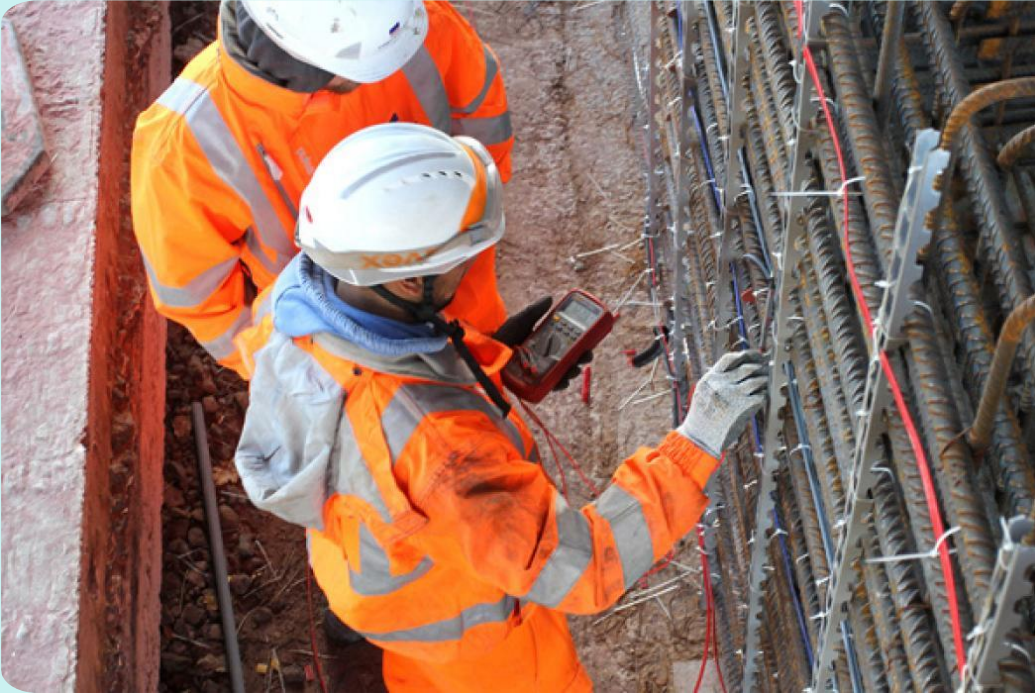
- As with all CP systems, **extreme care** is required during installation to eliminate risks of short-circuits, discontinuity, poor quality backfilling or electrical works
- With Prestressed Concrete, the risks associated with these considerations are amplified.
- Robust Quality Control systems are required, Routine inspections, hold points, verification
- Test, Test, Test... Then Proceed.
- Working with prestressed concrete presents some unique challenges.

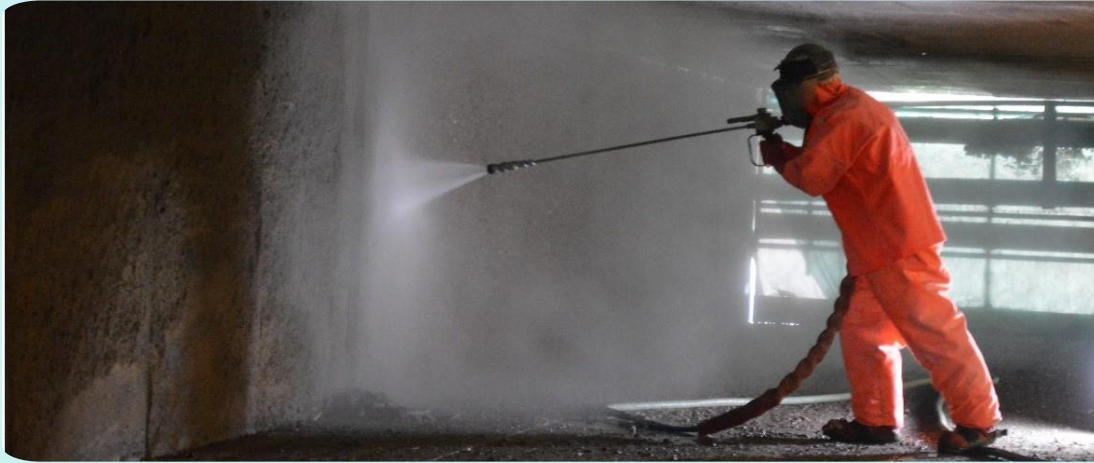
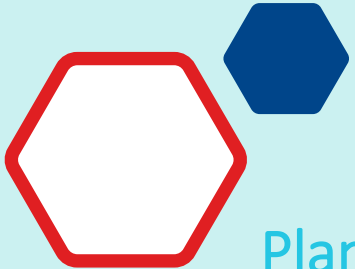
- If not completed correctly, repairs to prestressed concrete can risk **Destressing** the tendons.
- **Staging is key** to minimize any temporary reduction in structural capacity and limit the quantity of concrete material for removal at any one time.
- During the BLB 1 project consultation from structural engineers was sought to develop standard repair guidelines to inform the works.
- **Additionally**, Use of cutting grinders & Percussive jackhammers can risk damaging the tendons
- Ultra-High Pressure Water jetting (**Hydrodemolition**) was used .
- Whilst Highly Effective; expensive for small repairs, safety considerations and high noise levels.

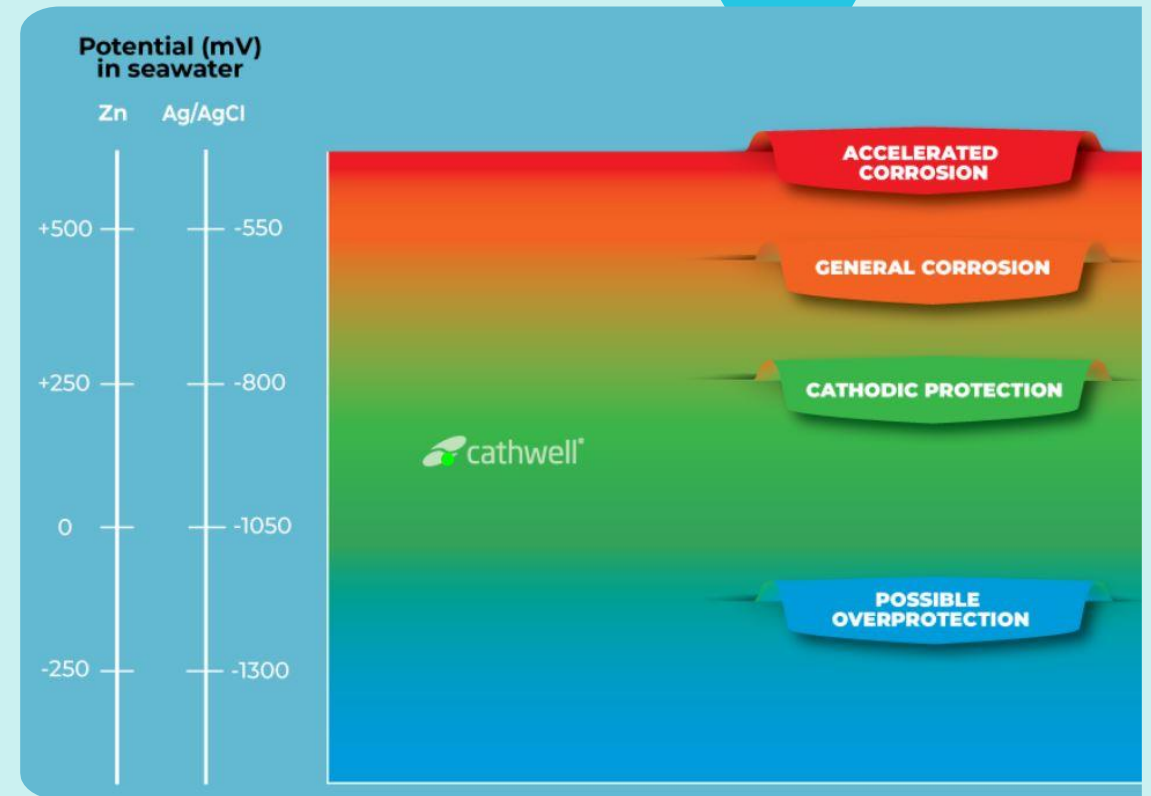
- “Overprotection” occurs when the reinforcing steel is polarized beyond optimal levels and can result in hydrogen embrittlement of the steel – **Reducing Ductility!**
- The Energisation phase of the Hybrid Process presents very real risks of overprotection if not managed properly.
- BLB 1 Project adopted a sophisticated remote monitoring and control system for all temporary power supplies
 - Alarms (Email & SMS)
 - Voltage & Current Limiters
 - Data Logging & Assessment
- Full Project Visibility – All Stakeholders
